# Manhole Inspection Summary

Manhole # S08II2006MH

**Location** Address: **7301 Charlesworth Rd** Cross Street: **Park Heights Ave**

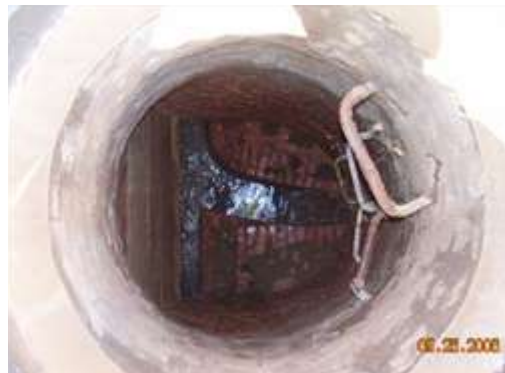
Top View

Corroded steps. Bench debris.

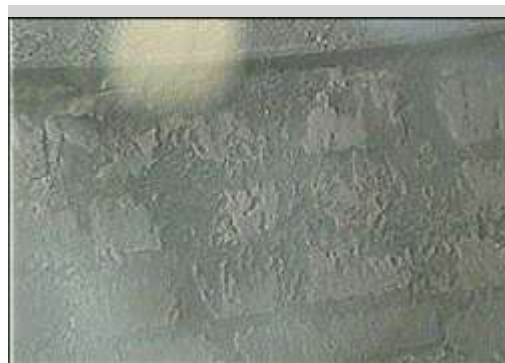
Defect

**Frame** Offset: **0** (in.) Condition: ☐ Sound ☐ Cracked ☒ **Leaks**

Frame leaks. Adjustment infiltration.

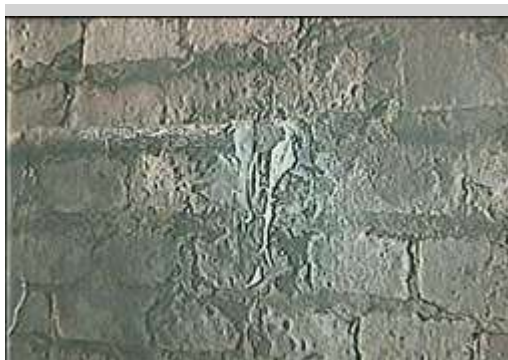
Defect

**Barrel** Material: **Brick** ☐ Parged  
Shape: **D-Shape** Diameter: **48** (in.) Length: **48** (in.)  
Condition: ☒ Sound ☐ Cracked ☐ Root Intrusion ☐ Loose Brick ☐ Deteriorated  
Infiltration: ☐ None ☐ Joint ☐ Cracks ☒ **Mortar** ☐ Roots ☐ Wall

Barrel deterioration and infiltration.

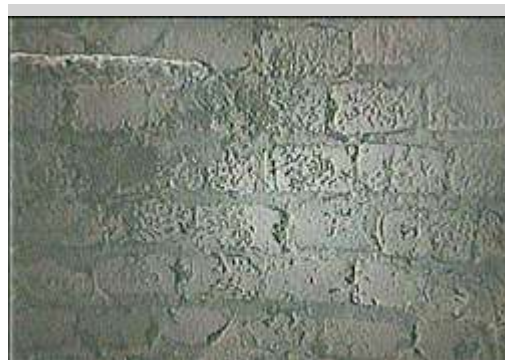
Defect

**Surcharge** ☒ **Evidence Of Surcharge** Depth: **5** (ft.) ☐ Active Surcharge Present

Evidence of surcharge.

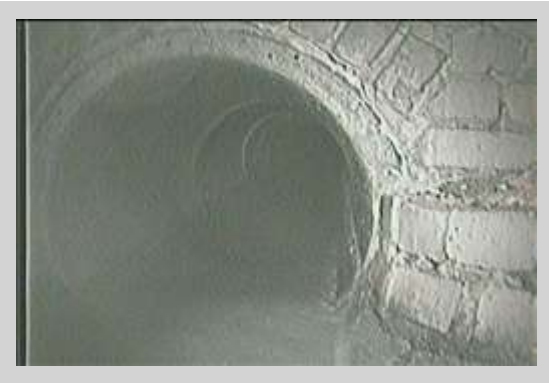
### 18 in. Circular Gravity Sewer Pipe Out @ 12 O'Clock

Pipe Material: **Clay** ☐ Pipe Lined

Invert Depth: **12.59** (ft.) Flow Characteristics: **Fast**

Infiltration: **None** Pipe Seal Cond: **Sound**

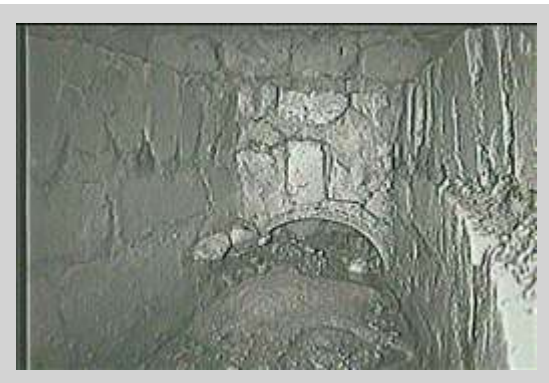
### 8 in. Circular Gravity Sewer Pipe In @ 3 O'Clock

Deposits: ☐ None ☐ Mud ☐ Sludge ☒ **Debris** ☐ Grease

Silt Depth: **7** (in.) Deposits Extent: **Heavy**

Drop Condition: **Clogged**

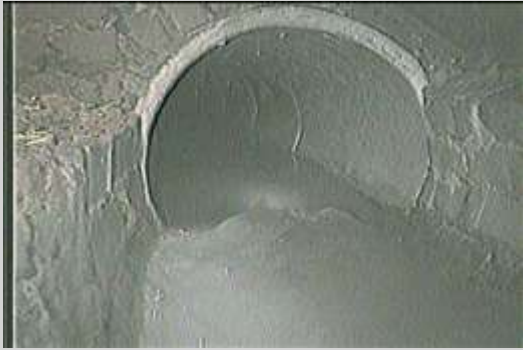
Pipe In @ 6 O'Clock

Invert Depth: **12.54** (ft.) Flow Characteristics: **Fast**

Deposits: ☒ None ☐ Mud ☐ Sludge ☐ **Debris** ☐ Grease

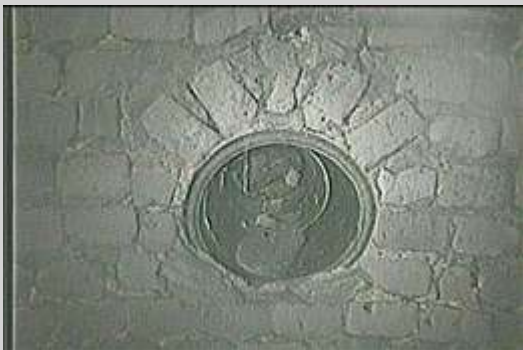
Pipe In @ 9 O'Clock

Deposits: ☐ None ☐ Mud ☐ Sludge ☒ **Debris** ☐ Grease

Silt Depth: **7** (in.) Deposits Extent: **Heavy**
